Manhole Inspection Summary

Manhole # S35II_016MH

Insp Date: **3/12/07 1:17 PM**

Location Address: **1629 SAINT PAUL ST**

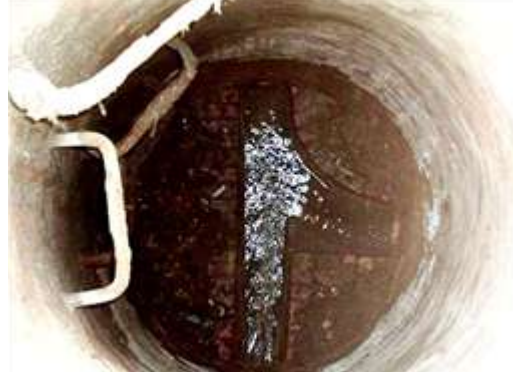
Top View

Corroded steps. Evidence of surcharge - Bench debris. Channel debris.

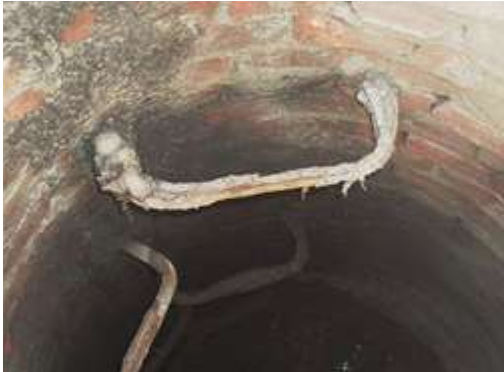
Defect

Adjustment and Corbel deterioration and infiltration. Barrel infiltration.

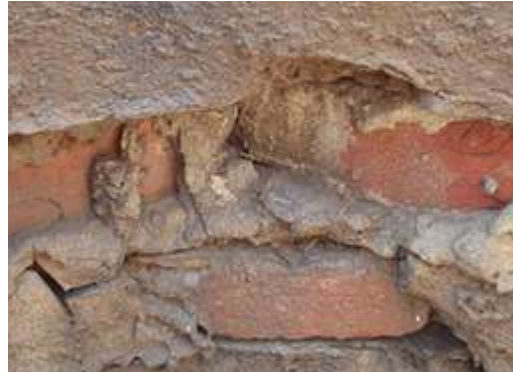
Defect

Frame leaks. Adjustment deterioration and infiltration.

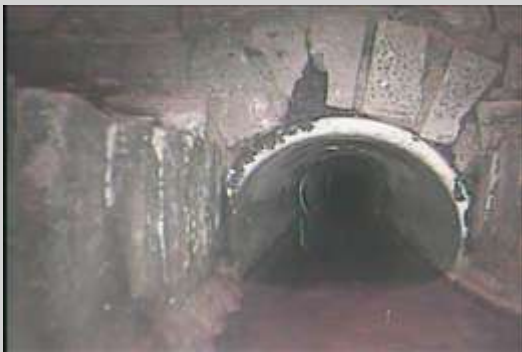
8 in. Circular Gravity Sewer Pipe Out @ 12 O'Clock

Infiltration: **Evidence** Pipe Seal Cond: **Unknown**
